Debris/Ice/TPS Assessment and Integrated Photographic Analysis of Shuttle Mission STS-92

**DEBRIS/ICE/TPS ASSESSMENT
AND
INTEGRATED PHOTOGRAPHIC ANALYSIS
OF
SHUTTLE MISSION STS-92**

11 October 2000

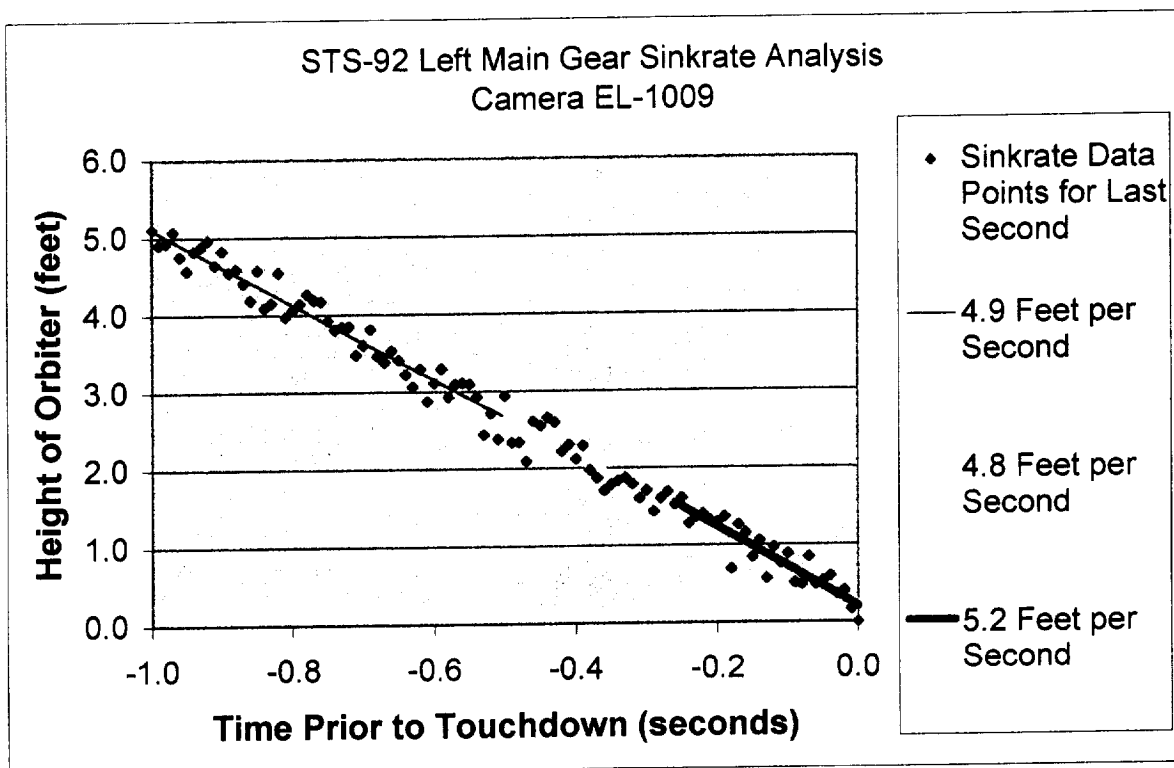
Figure 2.6 (A) Main Gear Landing Sink Rate

Straight lines were fit to the data for the final one-second, the final half-second, and the final quarter-second prior to touchdown of the left main gear. The slope of these lines define the sink rate for each interval and are listed in Table 2.6 along with the associated uncertainties based on the line fits. A plot describing these sinkrates is shown in Figure 2.6 (A).

The maximum allowable main gear sink rate values are 9.6 feet/second for a 212,000 lb. vehicle and 6.0 feet/second for a 240,000 lb. vehicle. The landing weight of the STS-92 vehicle was estimated to be 205,123 lbs.

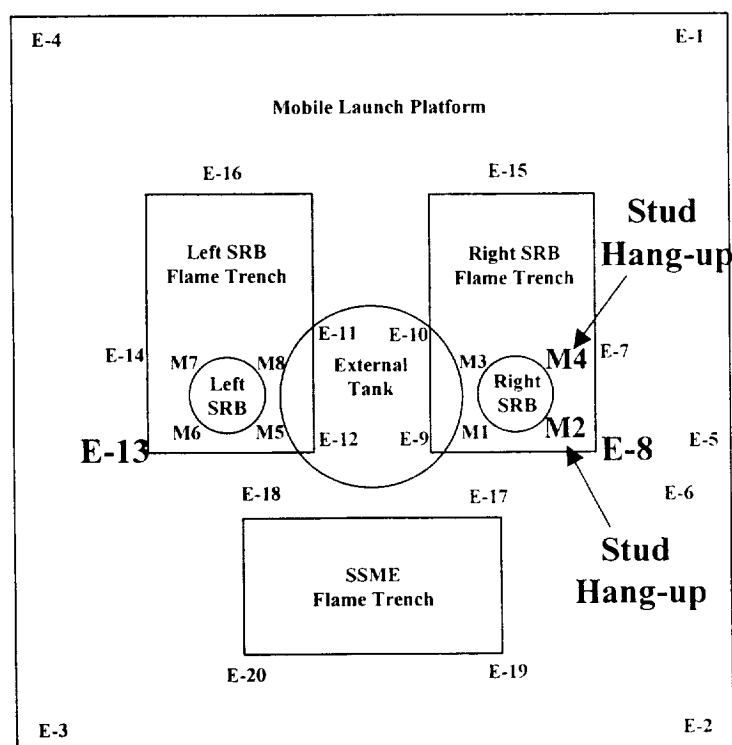
Figure 9. Camera Positions on Mobile Launch Platform

A stud hang-up occurred at Holddown Post M-4. A small piece of debris was imaged in Figure 6, which appeared to be ejected from the Holddown Post hole. Camera positions on the MLP are illustrated in Figure 9.

A stud hang-up occurred at Holddown Post M-2. Camera positions on the MLP are illustrated in Figure 9.

A single point on each SRB Aft Skirt was tracked with two film cameras. Film camera E8 followed a point on the SRB at Holddown Post M-2 and Film camera E13 followed a point on the SRB at Holddown Post M-6. Although the stud hang-up occurred on Holddown Post M4, film from Camera E7 was too dark to follow a point in the field of view until after firing of the SRBs. Camera Positions for E8 and E13 are noted in Figure 9.

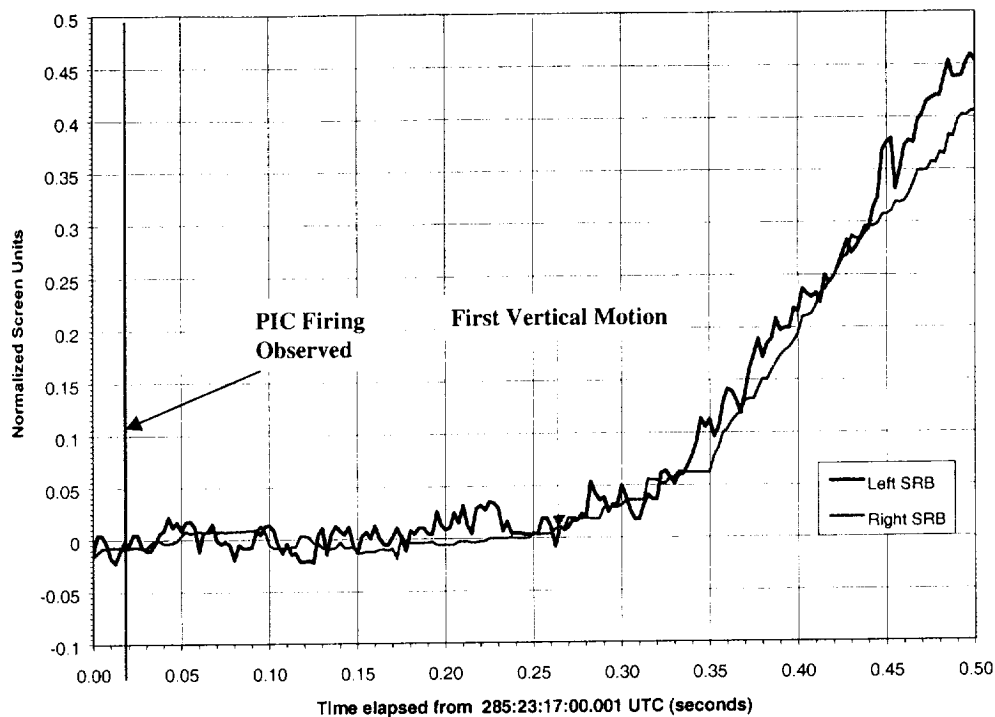
Figure 10. First Motion of STS-92 SRBs

Two stud hang-ups were observed on SRBs for STS-92 at liftoff. MSFC SRB Project Office requested Engineering Photographic Analysis provide an estimate of the time of first vertical motion as recorded from STS-92 launch films. Results of the investigation were delivered to Brian Pung (MP41).

Time on the graph in Figure 10 is in seconds from 285:23:17:00.001 UTC. The Y-coordinates are in film analyzer screen units and are directly related to vertical motion of the SRB. First Vertical Motion is estimated at 285:23:17:00.264 UTC as determined by plotting SRB vertical motion. This yields a first vertical motion at approximately 0.253 second MET.
